Montgomery County Fire and Rescue Service

POST INCIDENT ANALYSIS

**2nd Alarm Apartment Fire
101 Walsh View Terrace
Silver Spring, MD**

Incident Date: January 26, 2009

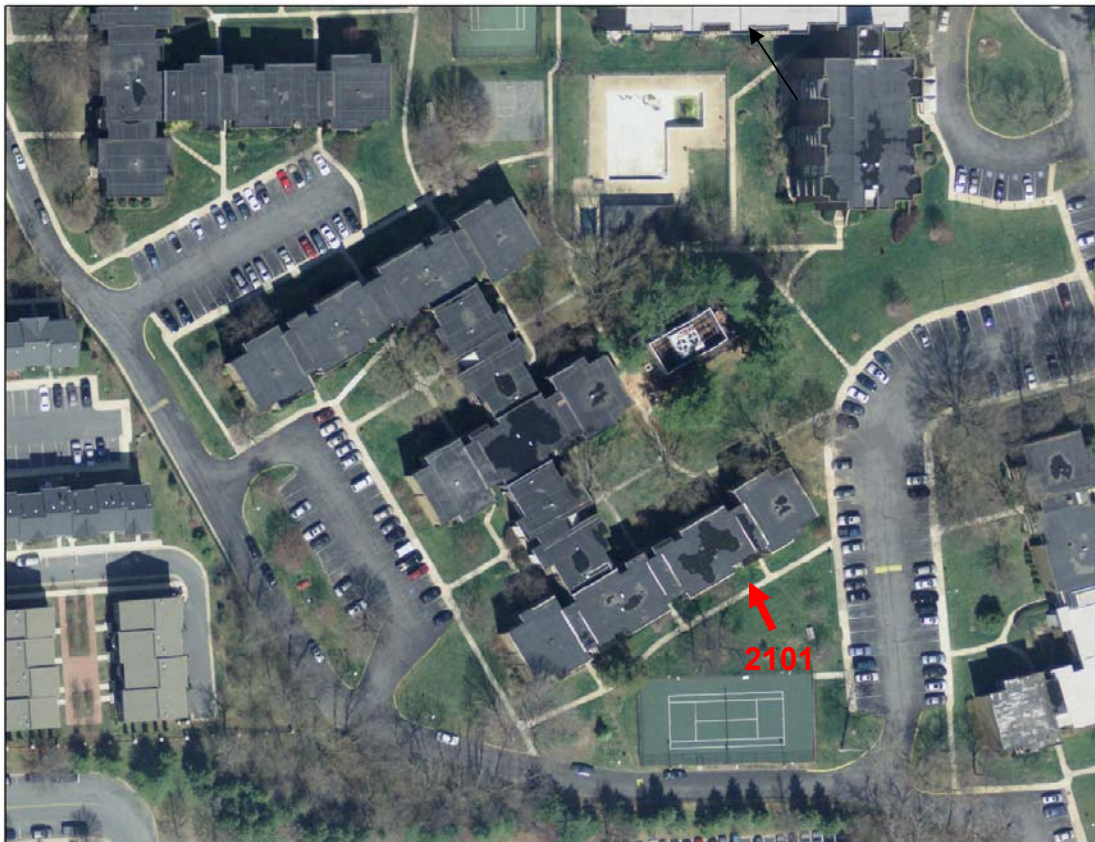
Structure/Site Layout

- The structure at 2101 Walsh View Terrace is part of a much larger garden apartment-style complex which includes multiple units and addresses.
- The complex is actually condominiums with a common layout of two units per floor instead of the often encountered four units per floor for a garden apartment layout.
- Several of the structures have a half basement/half crawl space arrangement used for storage and other activities.
- There is one centralized heating and hot water facility for the complex that supplies those utilities to the individual units.
- All of the condominium structures are Type 5 construction with no fixed fire suppression systems.
- The roofs of all structures in the complex are flat and constructed of dimensional lumber with a tar and chip surface covered with a rubber membrane assembly.
